INDOOR AIR QUALITY ASSESSMENT

**Woodland School
Alphabet Lane
Weston, Massachusetts**

Prepared by:
Massachusetts Department of Public Health
Bureau of Environmental Health Assessment
March 2003

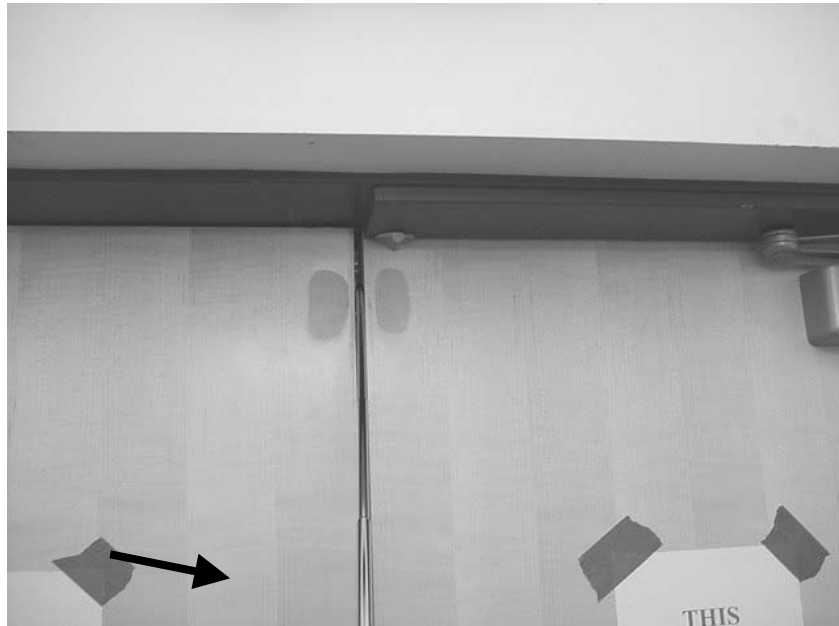
Picture 1

The school is currently under renovation while occupied by students, teachers and administrative staff. At the time of the inspection, the western portion of the school was under renovation. The hallway door leading to the renovation site was sealed with duct tape and plastic sheeting (see Picture 1). In addition, fiberglass insulation was inserted between the roof decking and the interior wall of the room that is adjacent to the area under renovation to provide a barrier (see Picture 2). An examination of the shared interior wall of room 133 was conducted. Cold air was noted penetrating into the classroom from the renovation area through (three) electrical sockets in the wall as well as light fixtures in the ceiling plenum (see Pictures 3 and 4). Unsealed spaces were also seen around pipes penetrating into the ceiling plenum.

The carbon monoxide and ultrafine particulate air testing indicate that seams (some sealed with duct tape) and spaces in temporary containment walls are not sufficient to prevent pollutant migration into occupied areas. Measures should be taken to reverse the air pressure relationship between the renovation areas and occupied spaces. Univents in all occupied classrooms should be operating to create positive pressure in classrooms. Once all univents are operating, general exhaust ventilation in classrooms should be reduced to maintain a slightly positive air pressure in classrooms.

Hallway Door near Food Prep Area, Note Seam in Tape

9. Seal all doors that access renovations with polyethylene plastic and duct tape on both sides of door.
10. Consider installing an air lock in areas that lead from the construction activities to the occupied section of the building. An airlock can be established by erecting a temporary wall with a door in close proximity to either an existing wall with door or another temporary wall with door. Each wall should be covered with continuous sheets of polyethylene plastic adhered with duct tape to seals seams in each airlock wall. Each door should be equipped with weather-stripping and a door sweep to prevent air movement through seams once the door is closed. Each door of the airlock should be equipped with a spring to automatically close the door. This configuration serves to prevent renovation generated pollutants from penetrating into occupied space. In order to prevent dust spread,

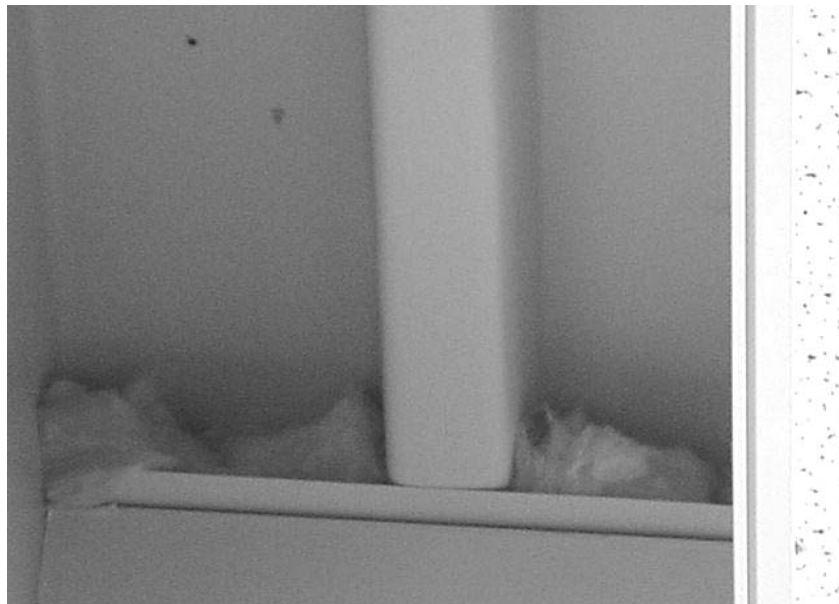
Picture 2

Fiberglass Insulation Inserted into Interior Wall/Roof Deck Joint in Room 133

8. Seal utility holes, electrical sockets, light fixtures, spaces in and around temporary walls and holes in interior walls of occupied areas adjacent to renovation areas to eliminate pollutant paths of migration.

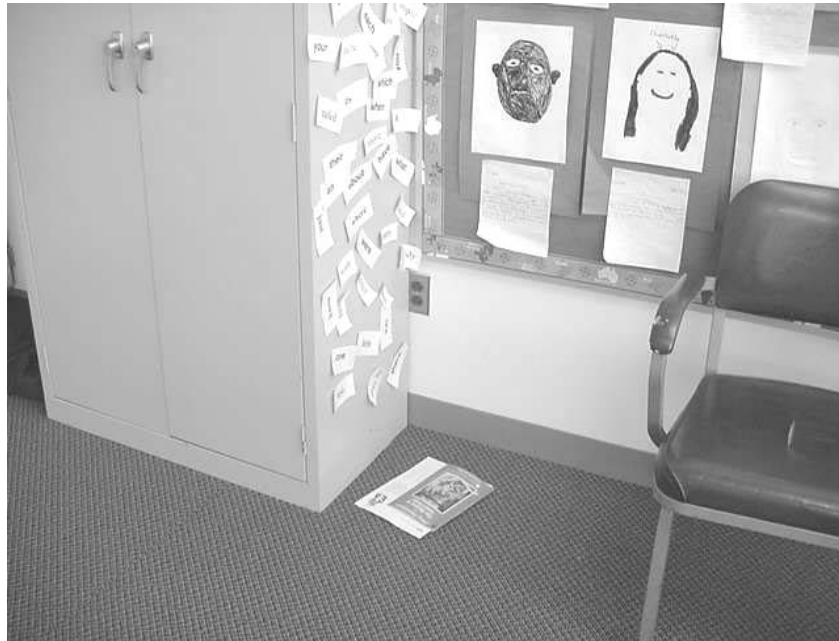
Picture 3

Electrical Sockets in Room 133

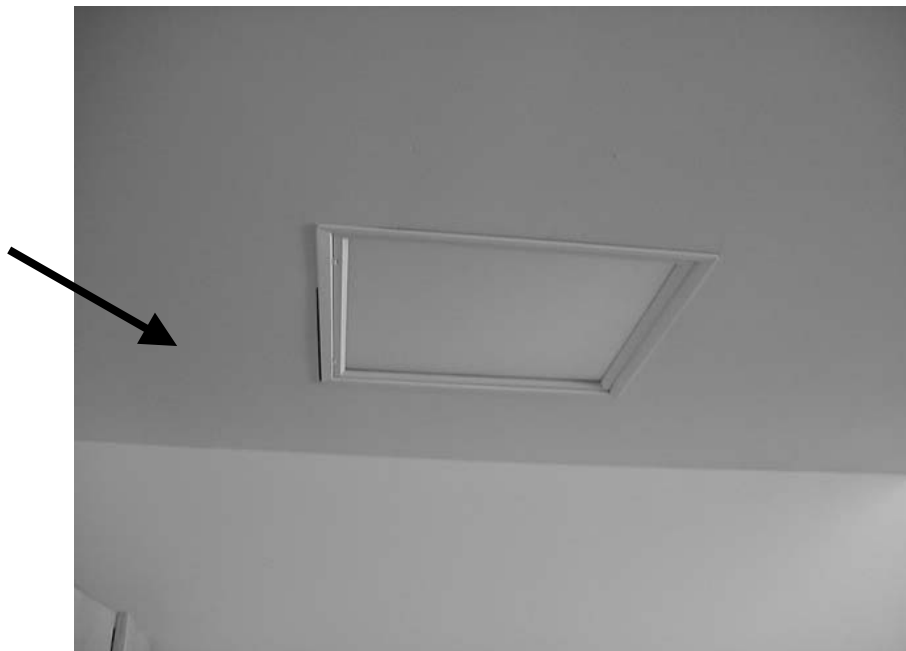
Picture 4

Light Fixture in Room 133. Note Space in Ceiling at Edge of Fixture

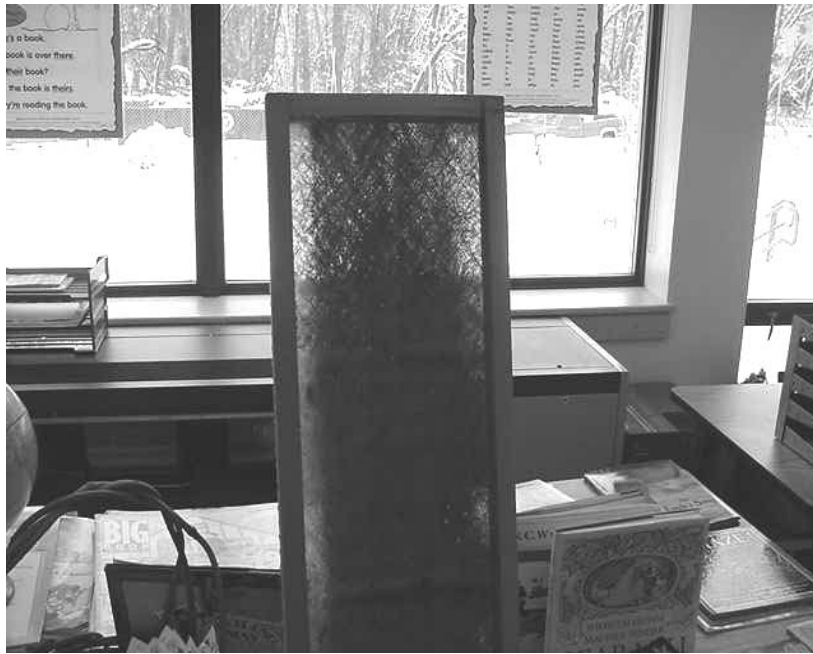
Picture 5

The interior of the univent in classroom 133 was also examined. The fresh air intake louver was set to allow minimum air infiltration. The operation of the univent to draw minimal fresh air from outdoors will limit the dilution of pollutants in this room. Univent filters were of a type that would provide minimal filtration of renovation pollutants (see Picture 5). In order to decrease aerosolized particulates, disposable filters with an increased dust spot efficiency can be installed in these units. Changes of filter medium in buildings under renovation should be increased to avoid saturation of the filter, which in turn can cause the filter to release pollutants.

Filter of Room 133 Univent, Note Light Passing through Filter

7. Use local exhaust ventilation and isolation techniques to control for renovation pollutants. Precautions should be taken to avoid the re-entrainment of these materials into the building's HVAC system. The design of each system must be assessed to determine how it may be impacted by renovation activities. Specific HVAC protection requirements pertain to the return, central filtration and supply components of the ventilation system. This may entail shutting down systems (when possible) during periods of heavy construction and demolition, ensuring systems are isolated from contaminated environments, sealing ventilation openings with plastic and utilizing filters with a higher dust spot efficiency where needed (SMACNA, 1995).
